Final report – cleaning machines used on Alloc HPL products

Initiated: Nov 06
 1. inspection: February 07
 2. inspection: June 07
 Final report: June 07

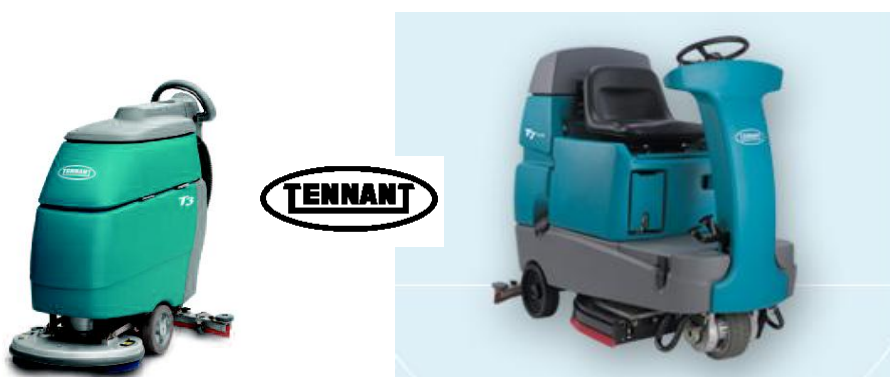
T-3: Walking behind moving machine

T7: Sitting on moving machine
